# CASE HISTORY

## BBZ RESIN INJECTION SYSTEMS

<b>Project:</b>	<b>Logan International Airport International Gateway Terminal E-East Boston, MA</b>	<b>Engineer:</b>	<b>Heidlinger Associates</b>
<b>Owner:</b>	<b>Massachusetts Port Authority</b>	<b>GC:</b>	<b>Modern Continental International Gateway Office</b>
<b>Injection System:</b>	<b>Duroseal Inject</b>	<b>Completed:</b>	<b>April 2001</b>

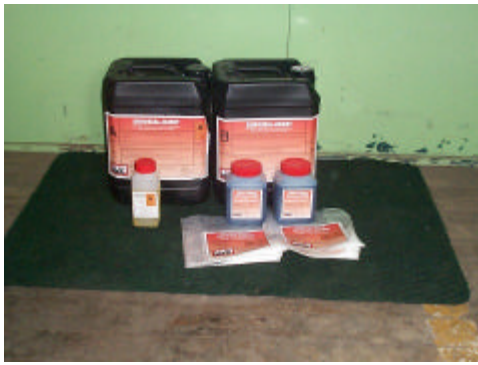
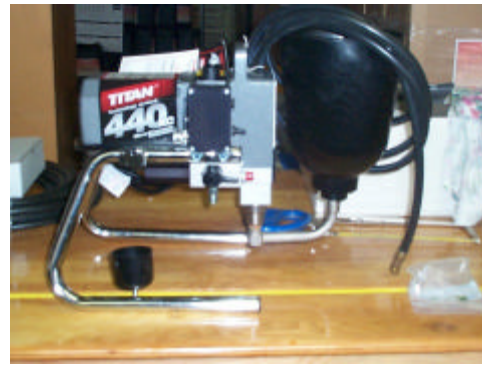
BBZ USA Inc. was asked to look at an area of the cellar of the new Terminal E of the International Gateway. The area had already been injected twice with polyurethane, but the leak had reappeared. A site survey led to the conclusion that the area could be sealed with Duroseal Inject.

**Duroseal Inject**, a solvent-free, water-soluble injection resin, was chosen for this particular repair. Due to its low viscosity and low flow resistance, **Duroseal Inject** is able to penetrate into even the smallest cracks and capillaries. These are areas where polyurethanes, with their higher viscosity, cannot penetrate.

Drilling was done at a 45° angle to the crack or joint until one-half of the wall thickness is reached. Drilling on alternating sides for the length of the crack to be injected. The injection material is introduced through a 1-component pump into the injection packer. Due to its low viscosity, **Duroseal Inject** is able to penetrate even the smallest of cracks where the polyurethane failed to reach.
